AVIATION INVESTIGATION REPORT

A00C0059

LOSS OF CONTROL ON GO-AROUND

POINTS NORTH AIR SERVICES INC.
DOUGLAS AIRCRAFT COMPANY DC-3 C-FNTE
ENNADAI LAKE, NUNAVUT
17 MARCH 2000

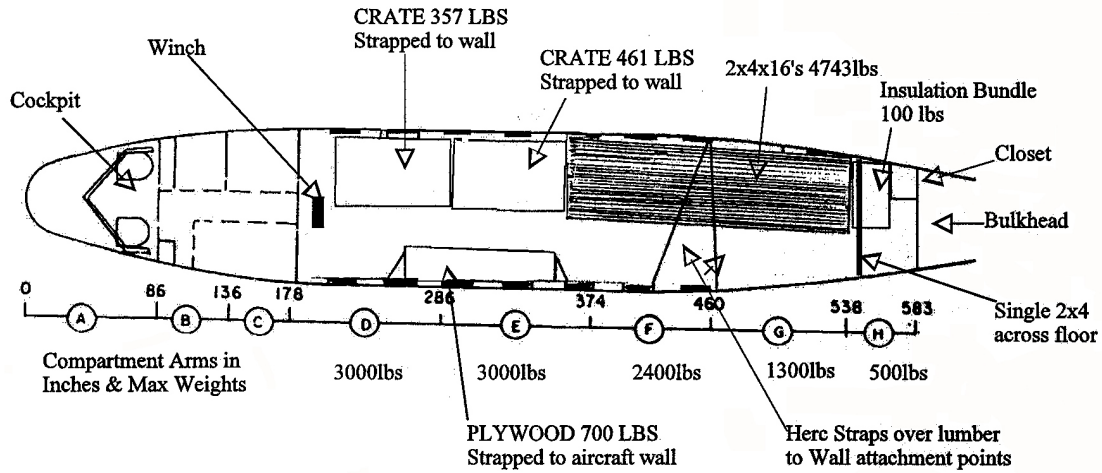
Appendix A—Load Distribution

Wreckage examination confirmed the position of the loads in the aircraft and the method of tie-down as shown in Appendix A. The aircraft's nose and cockpit section were destroyed by impact forces. The fuselage failed in full-circumference just aft of the trailing edge of the wings. The two crates remained secured in this area. Several sheets of plywood also remained in place in front of the fuselage failure. The fuselage, aft of the wings, and the tail were twisted to the left and downwards. The remainder of the plywood sheets had dropped into the space in the fuselage opening aft of the wings. A second, almost full-circumference failure of the fuselage occurred in the vicinity of the forward portion of the vertical fin and ahead of both horizontal stabilizer attachments. All of the 2x4s were found in the rearmost section of the fuselage, with a large number found aft of the rear bulkhead.

5. The stack of 2x4 lumber was inadequately secured and may have shifted rearward during the go-around.
6. The crew did not recalculate the aircraft's weight and balance for the second flight.
7. Leaks in the heater shroud allowed carbon monoxide gas to contaminate cockpit and cabin air.
8. The captain's carboxyhaemoglobin level was 17.9 per cent, which may have adversely affected his performance, especially his decision making and his visual acuity.

1. First 2-3 rows of 2x4's extend beyond edge of rear crates.
2. Herc straps over lumber are attached to aircraft wall not floor points.
3. Insulation bundle extends beyond closet.
4. Weight of 2x4's exceeds combined weights of Compartments F & G
